# Manhole Inspection Summary

Manhole # S39I\_\_010MH

Insp Date: **1/21/09 2:18 PM**

**Location** Address: **side of 204 e pratt st**

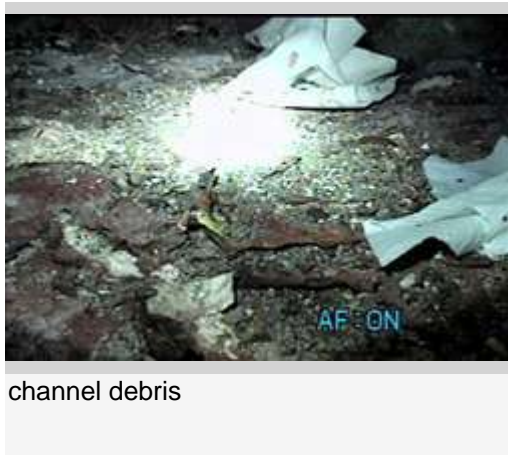
MISC

channel debris

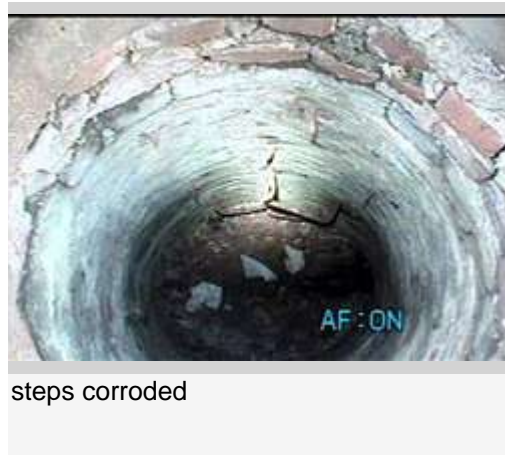
Defect 3

Count: **6** Missing: **3** ☒ **Corroded**

steps corroded

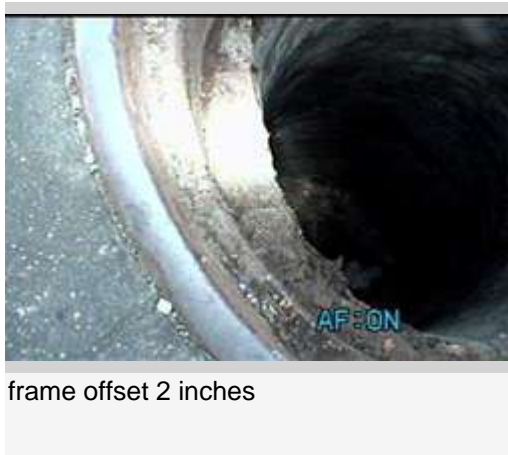
Defect 2

Offset: **2** (in.)

frame offset 2 inches

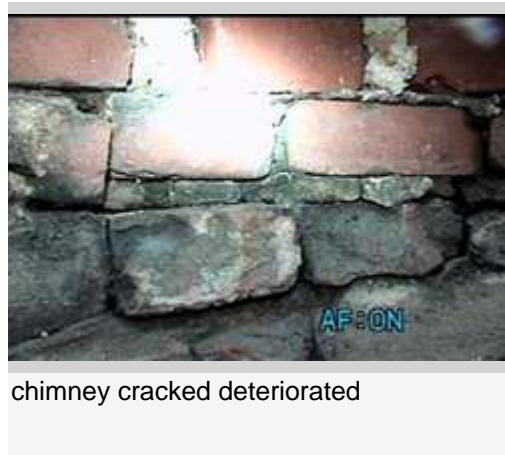
Defect 1

Condition: ☐ Sound ☒ **Cracked** ☐ Root Intrusion ☐ Loose Brick ☒ **Deteriorated**

chimney cracked deteriorated
